A/C System Test 9/11/2024, 10:52:35 AM

Diagnostic Report

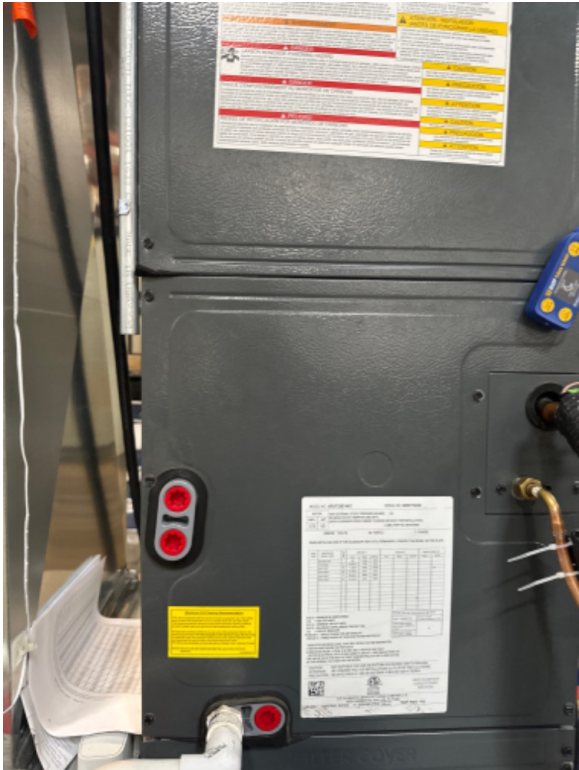
Equipment Models & Serials

Make: Goodman
Model: VSX130181
Serial: 1909035516

Make: Goodman
Model: ARUF25B14
Serial: 2009176230
